PIC18F2515/2610/4515/4610 Rev. A4 Silicon Errata

The PIC18F2515/2610/4515/4610 Rev. A4 parts you have received conform functionally to the Device Data Sheet (DS39636D), except for the anomalies described below. Any Data Sheet Clarification issues related to the PIC18F2515/2610/4515/4610 will be reported in a separate Data Sheet errata. Please check the Microchip web site for any existing issues.

The following silicon errata apply only to PIC18F2515/2610/4515/4610 devices with these Device/Revision IDs:

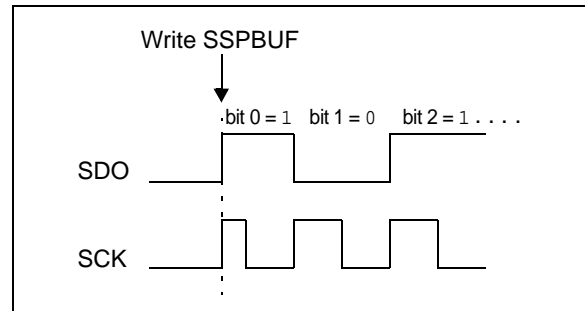
FIGURE 1: SCK PULSE VARIATION USING TIMER2/2

When the SPI is using Timer2/2 as the clock source, a shorter than expected SCK pulse may occur on the first bit of the transmitted/received data (Figure 1).

To avoid producing the short pulse, turn off Timer2 and clear the TMR2 register, load the SSPBUF with the data to transmit and then turn Timer2 back on. Refer to Example 6 for sample code.
