XE166 Derivatives

Real Time Signal Controller

Errata Sheet

V1.6 2014-10

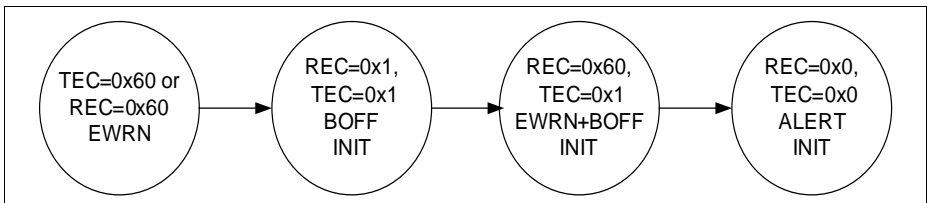
Figure 5 Alert Interrupt Behavior in case of Bus-Off

MultiCAN AI.H007 Alert Interrupt Behavior in case of Bus-Off

The MultiCAN module shows the following behavior in case of a bus-off status:

When the threshold for error warning (EWRN) is reached (default value of Error Warning Level EWRN = 0x60), then the EWRN interrupt is issued. The bus-off (BOFF) status is reached if TEC > 255 according to CAN specification, changing the MultiCAN module with REC and TEC to the same value 0x1, setting the INIT bit to 1_B, and issuing the BOFF interrupt. The bus-off recovery phase starts automatically. Every time an idle time is seen, REC is incremented. If REC = 0x60, a combined status EWRN+BOFF is reached. The corresponding interrupt can also be seen as a pre-warning interrupt, that the bus-off recovery phase will be finished soon. When the bus-off recovery phase has finished (128 times idle time have been seen on the bus), EWRN and BOFF are cleared, the ALERT interrupt bit is set and the INIT bit is still set.

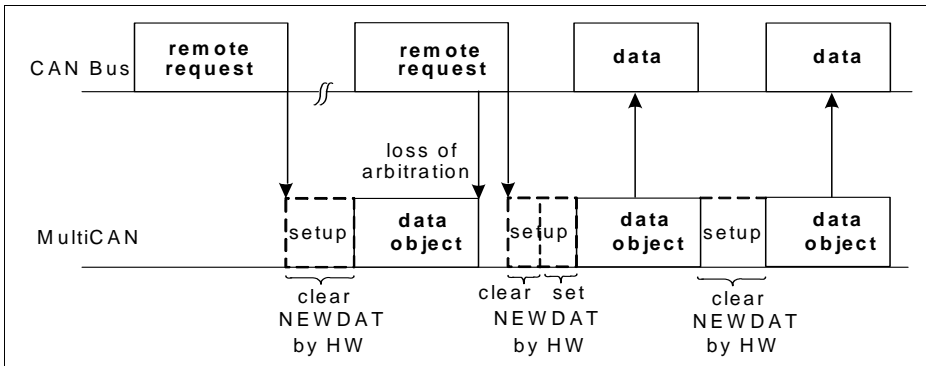
Figure 6 Loss of Arbitration

When the appropriate message object (data frame) triggered by the first remote frame wins the arbitration, it will be sent out and NEWDAT is not reset. This leads to an additional data frame, that will be sent by this message object (clearing NEWDAT).

There will, however, not be more data frames than there are corresponding remote requests.
