PIC18F2410/2510/4410/4510 Rev. B4 Silicon Errata

The PIC18F2410/2510/4410/4510 Rev. B4 parts you have received conform functionally to the Device Data Sheet (DS39636D), except for the anomalies described below. Any Data Sheet Clarification issues related to the PIC18F2410/2510/4410/4510 will be reported in a separate Data Sheet errata. Please check the Microchip web site for any existing issues.

The following silicon errata apply only to PIC18F2410/2510/4410/4510 devices with these Device/Revision IDs:

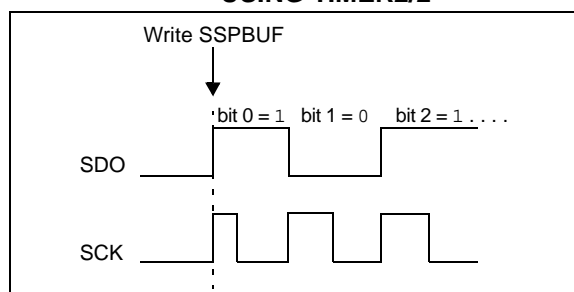
FIGURE 1: SCK PULSE VARIATION USING TIMER2/2

When the SPI is using Timer2/2 as the clock source, a shorter than expected SCK pulse may occur on the first bit of the transmitted/received data (Figure 1).

To avoid producing the short pulse, turn off Timer2 and clear the TMR2 register, load the SSPBUF with the data to transmit and then turn Timer2 back on. Refer to Example 1 for sample code.
